Test
Report

Our Ref: GBW Number 137009 Issue 1 Date 22/05/2015 Page 1 of 4

SALT SPRAY TESTING OF YELLOW POWDERCOAT TUBE SAMPLE

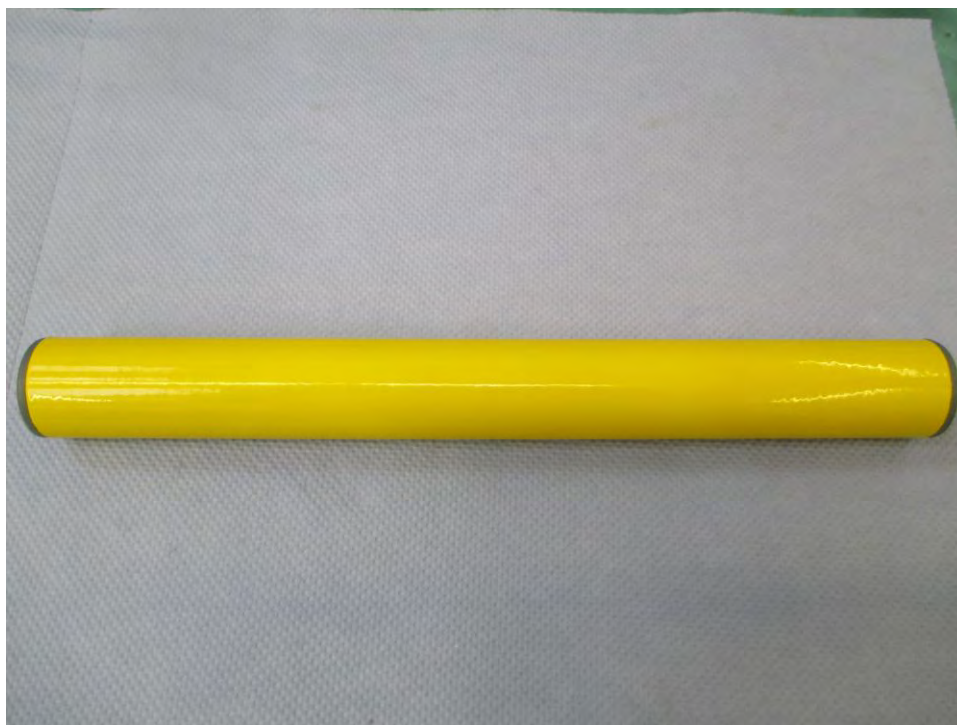
Pre – Test Assessment showed a number of seeds on the surface finish.

Fig 1: Photograph showing the condition of the 33.7 x 250mm Tube Sample prior to Salt Spray Test

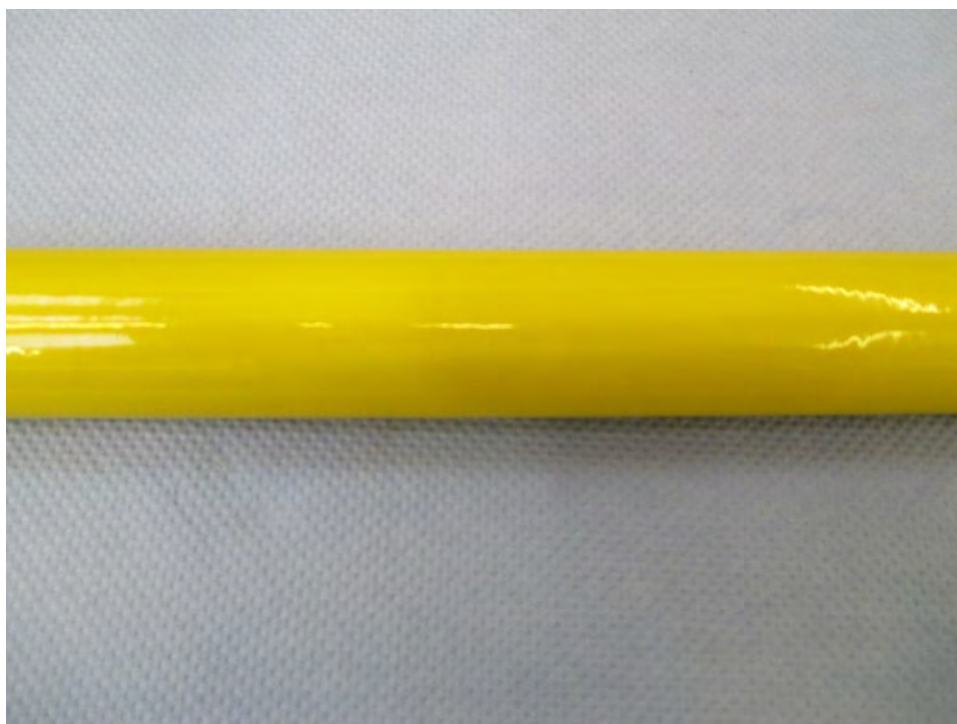
The photographs in fig 1 & 2 are showing the tube sample prior to test, the tube sample was then exposed to a neutral 5% Salt Spray for a test period of 216 hours, examinations after every 24 hours, revealed the following observations:-

Fig 2: Photograph showing the condition of the 33.7 x 250mm Tube Sample

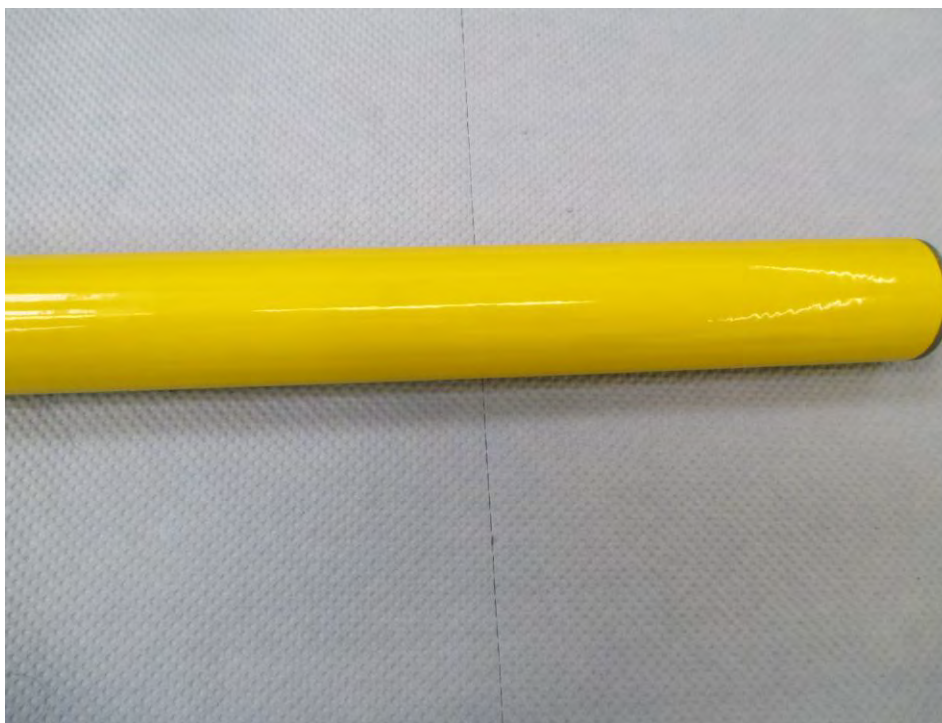
The tube sample showed no evidence of corrosion or deterioration of the finish (see photograph after 216 hours).

Fig 3: Photograph showing the condition of the 33.7 x 250mm Tube Sample after 216 hours Salt Spray Test

The finish applied to the 33.7 x 250mm Tube Sample tested, **withstood** 216 hours Salt Spray Test requirement without significant breakdown.

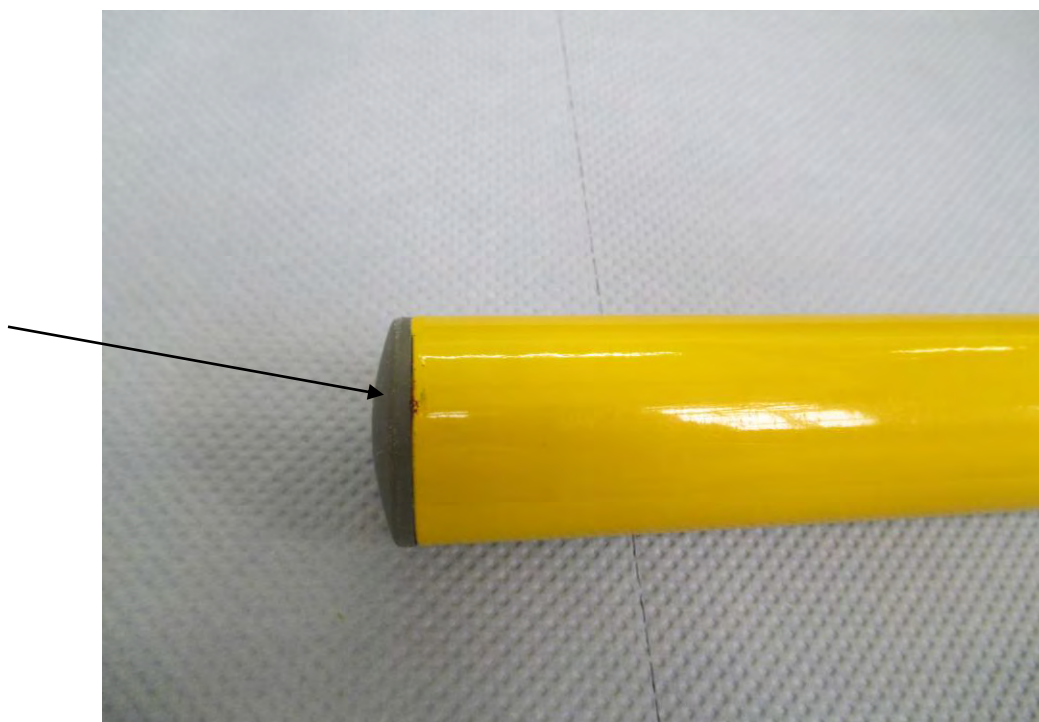
The tube sample showed evidence of one spot of red ferrous corrosion adjacent to the end cap, no other part of the tube sample showed evidence of corrosion or deterioration of the finish (see photographs after 216 hours).

Fig 4: Photograph showing the condition of the 33.7 x 250mm Tube Sample after 216 hours Salt Spray Test (corrosion spot)
